The Scotlandville, Denham Springs, and Baton Rouge Faults—

A Map Guide for Real Estate Buyers, Sellers, and Developers in the Greater Baton Rouge Area

PUBLIC INFORMATION SERIES No. 13
SUMMER 2008

by:
Richard P. McCulloh

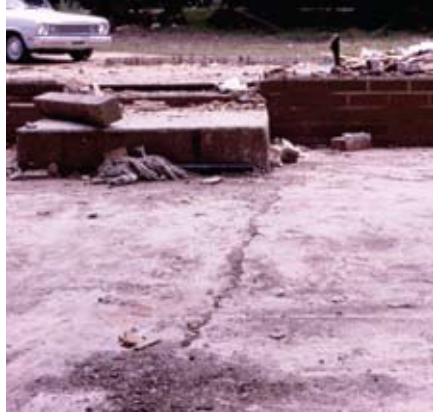
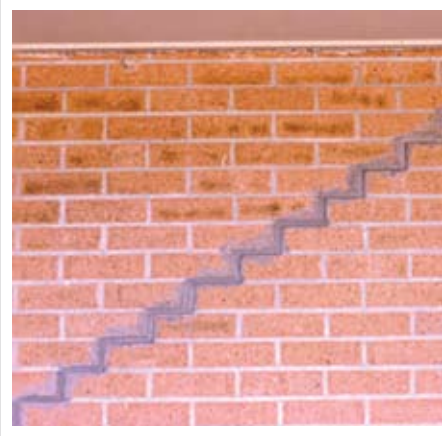
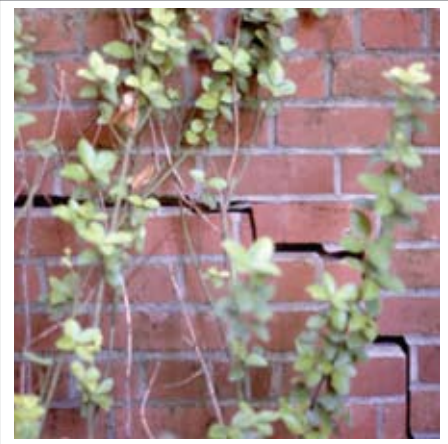
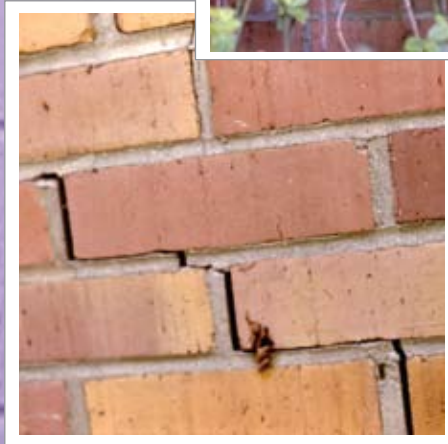
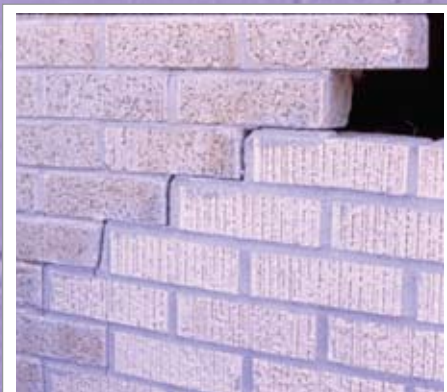
Front cover: Damage to structures built on and near faults of the Baton Rouge system in East Baton Rouge Parish, selected from photographs on file at the Louisiana Geological Survey taken during field work for the investigation by H. L. Roland, T. F. Hill, P. Autin, C. O. Durham, and C. G. Smith, *The Baton Rouge and Denham Springs–Scotlandville faults: mapping and damage assessment*, prepared for the Louisiana Department of Natural Resources by the Louisiana Geological Survey and Durham Geological Associates Consultants (1981). Photos by P. Autin and F. K. Kring.
